EASA JOURNAL

SUMMER 2017

FEATURES:
St Mary's, Weston-on-the-Green
Jesmond United Reformed Church

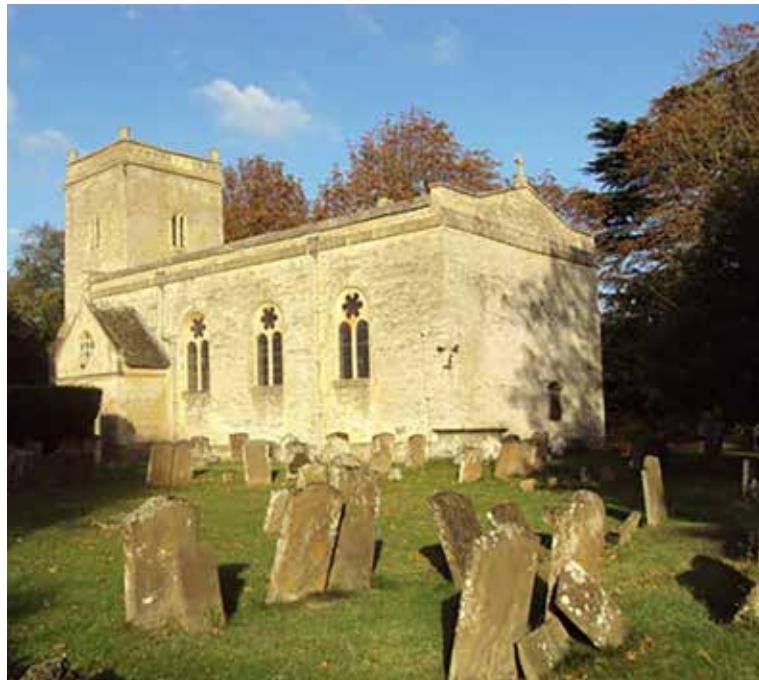
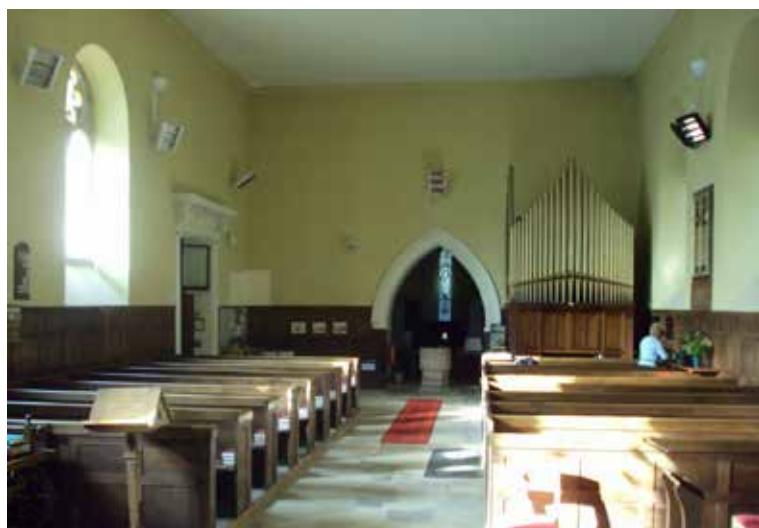
Within the Nave a coat of emulsion had been applied over the original lime wash - and approved by EH, according to the church! It had quickly failed, bubbling and lifting in large patches as well as contributing to some areas of plaster failure below windows where moisture was trapped behind it.

Interior in 2011

Removal of this top coat was important in order to allow the walls to breathe and also to improve the dilapidated look of the space. The paint had to be removed mechanically with scrapers, which was time consuming but did not damage

the surface below. A trial patch of paint had been removed beforehand and this method of removal found to be best. Around 90% was removed this way without damaging the plaster below. The remaining 10% was well adhered, indicating that it was not causing ongoing problems either to the plaster or to the breathability of the walls, so it was left rather than risking damage to the plaster.

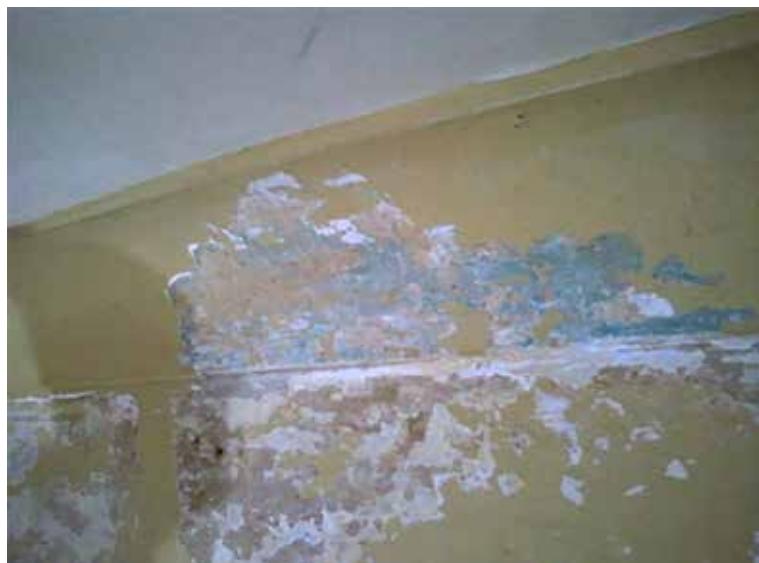
C18 paint finishes revealed

During the paint removal the original colours used for the walls and coving were revealed. The ornate C18 ceiling had collapsed around the mid-C19, so it is assumed that the colour scheme was from this later period. I was keen to reinstate the Victorian colour scheme of green coving with light tan walls (using samples of paint). However the church did not support this idea.

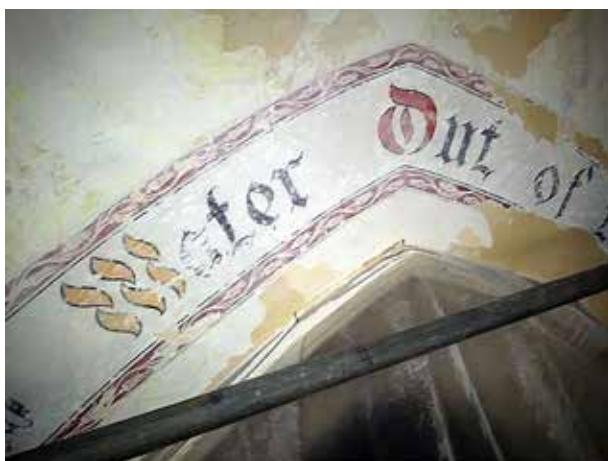
Banner uncovered over arch to tower

Another discovery was a Victorian banner over the arch into the tower, which read: 'Therefore with joy shall we draw water out of the wells of salvation' – Isaiah 12. The hand painted banner had survived very well and did not lift when the emulsion was removed. It had faded slightly through absorption to the emulsion (being water based paint) and there was some damage to the lower sections where electrical cables had been embedded in the walls. The discovery of this piece of Victorian embellishment captured the imagination of the parish and indeed the whole village. Recovering this previously lost feature added much to the outcome of the project.

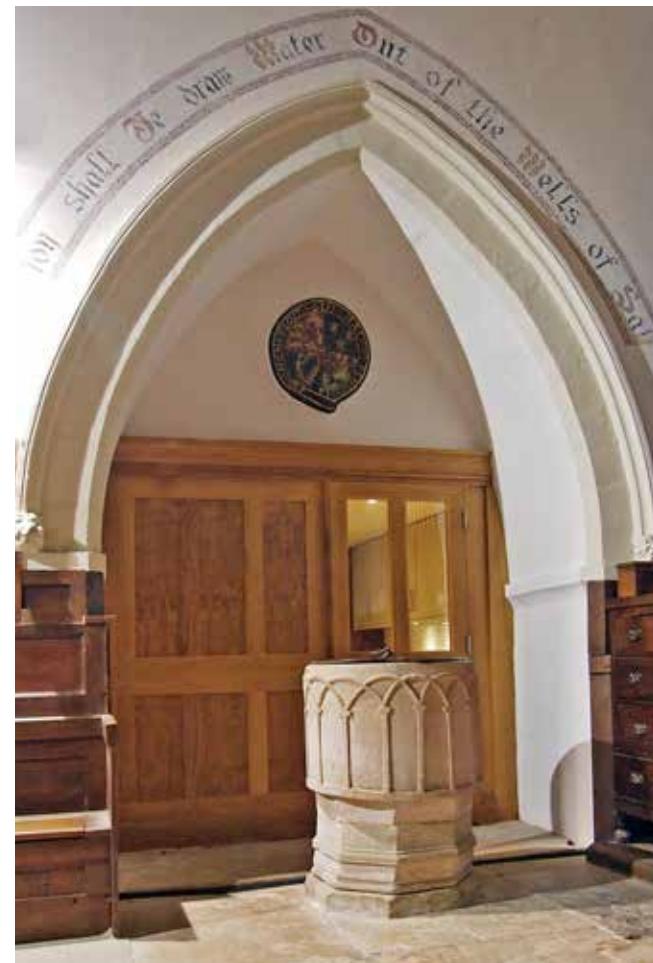
The solution was to offer a Kitchen and Vestry as well as a WC, over two levels within the tower. The new accommodation would be hidden behind an oak screen (with a door in it) to reflect the existing oak panelling, this would infill the arch to the tower but be recessed as far back as possible. Above the new oak panelling was a plain plaster panel which not only reduced the visual impact of the infill but allowed a better junction within the arch. This area was also a good place to mount a C17 boss which had been discovered beneath a chest of drawers in the original vestry. The idea was supported by the PCC and gained Faculty and funding over the following 12 months. The project was completed in June 2013.

Victorian banner and remounted boss above new panelling
